BCT Meeting

Remedial Action Update Parcel B (Excluding IR Sites 7 & 18)

August 29, 2013

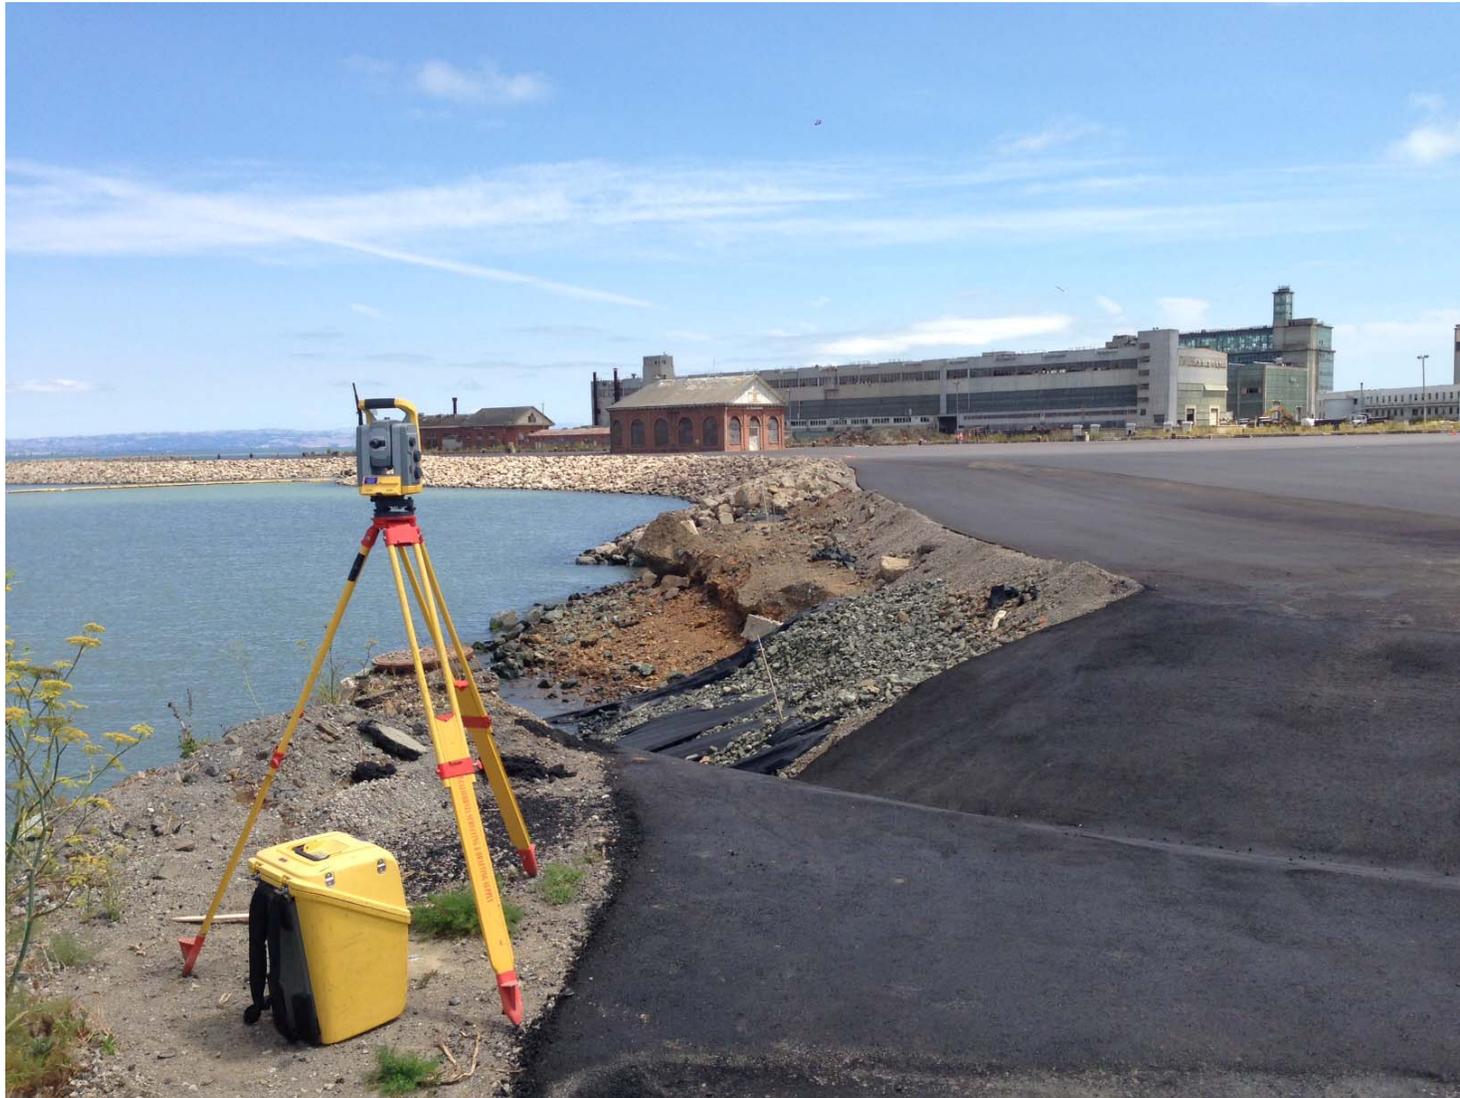
Unfinished Revetment at Combined Site Paved To Revetment Crest

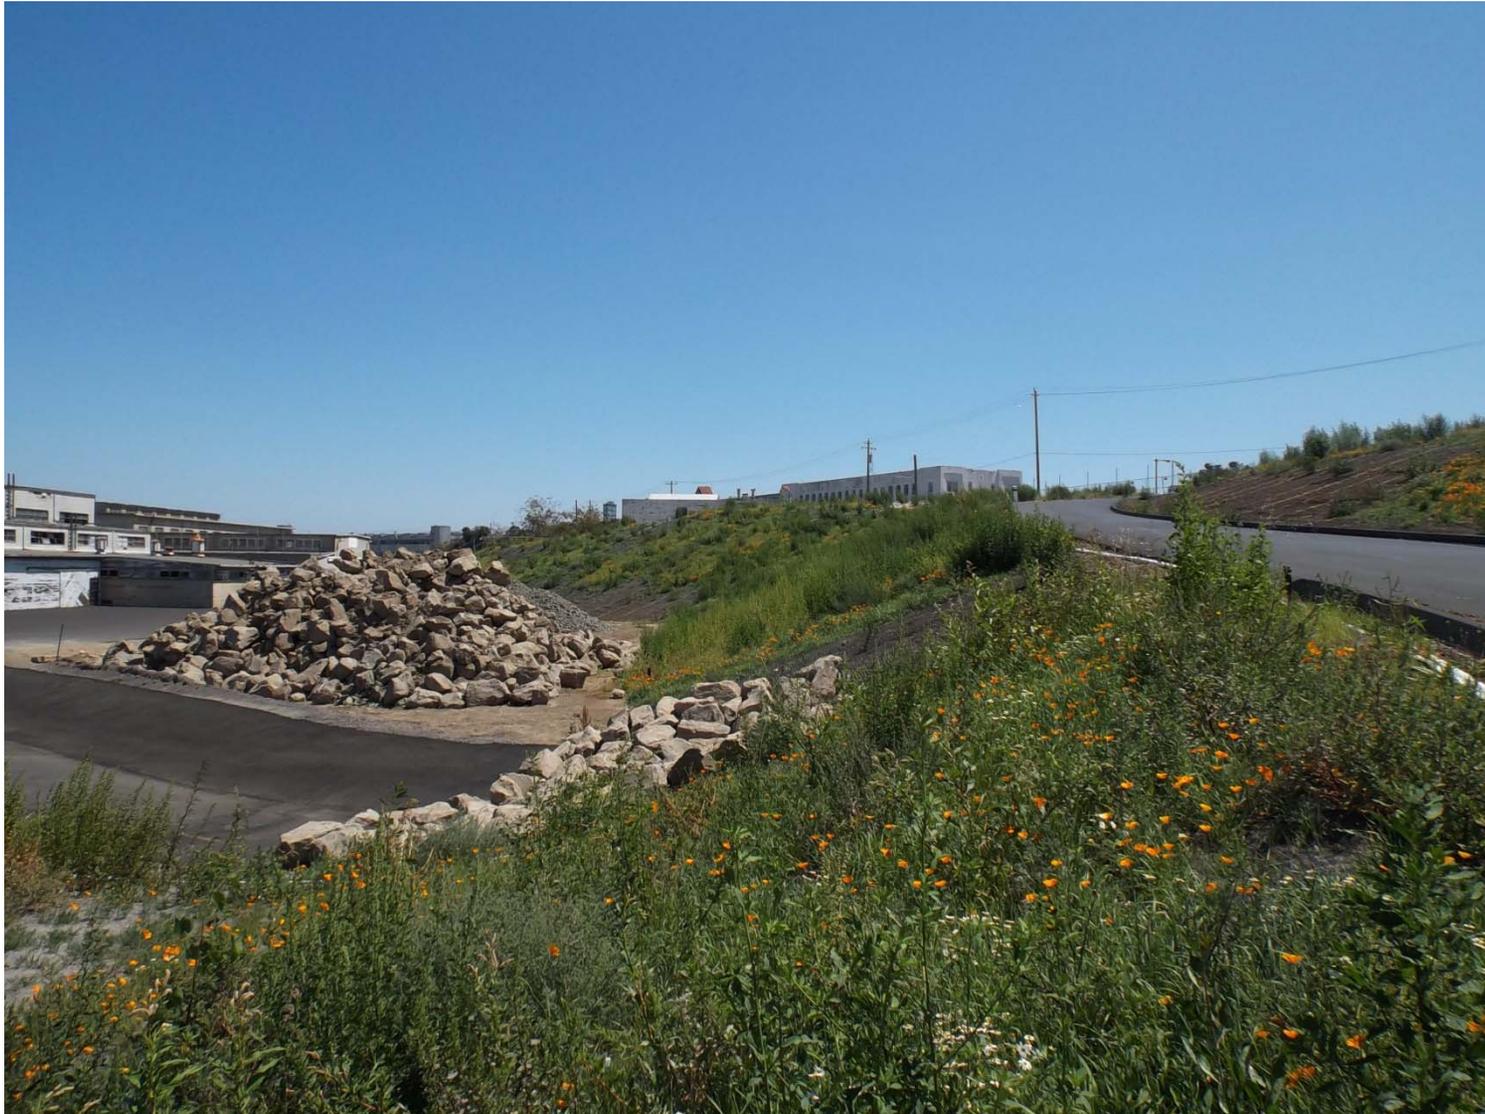
Soil Cover Vegetation Establishment Underway

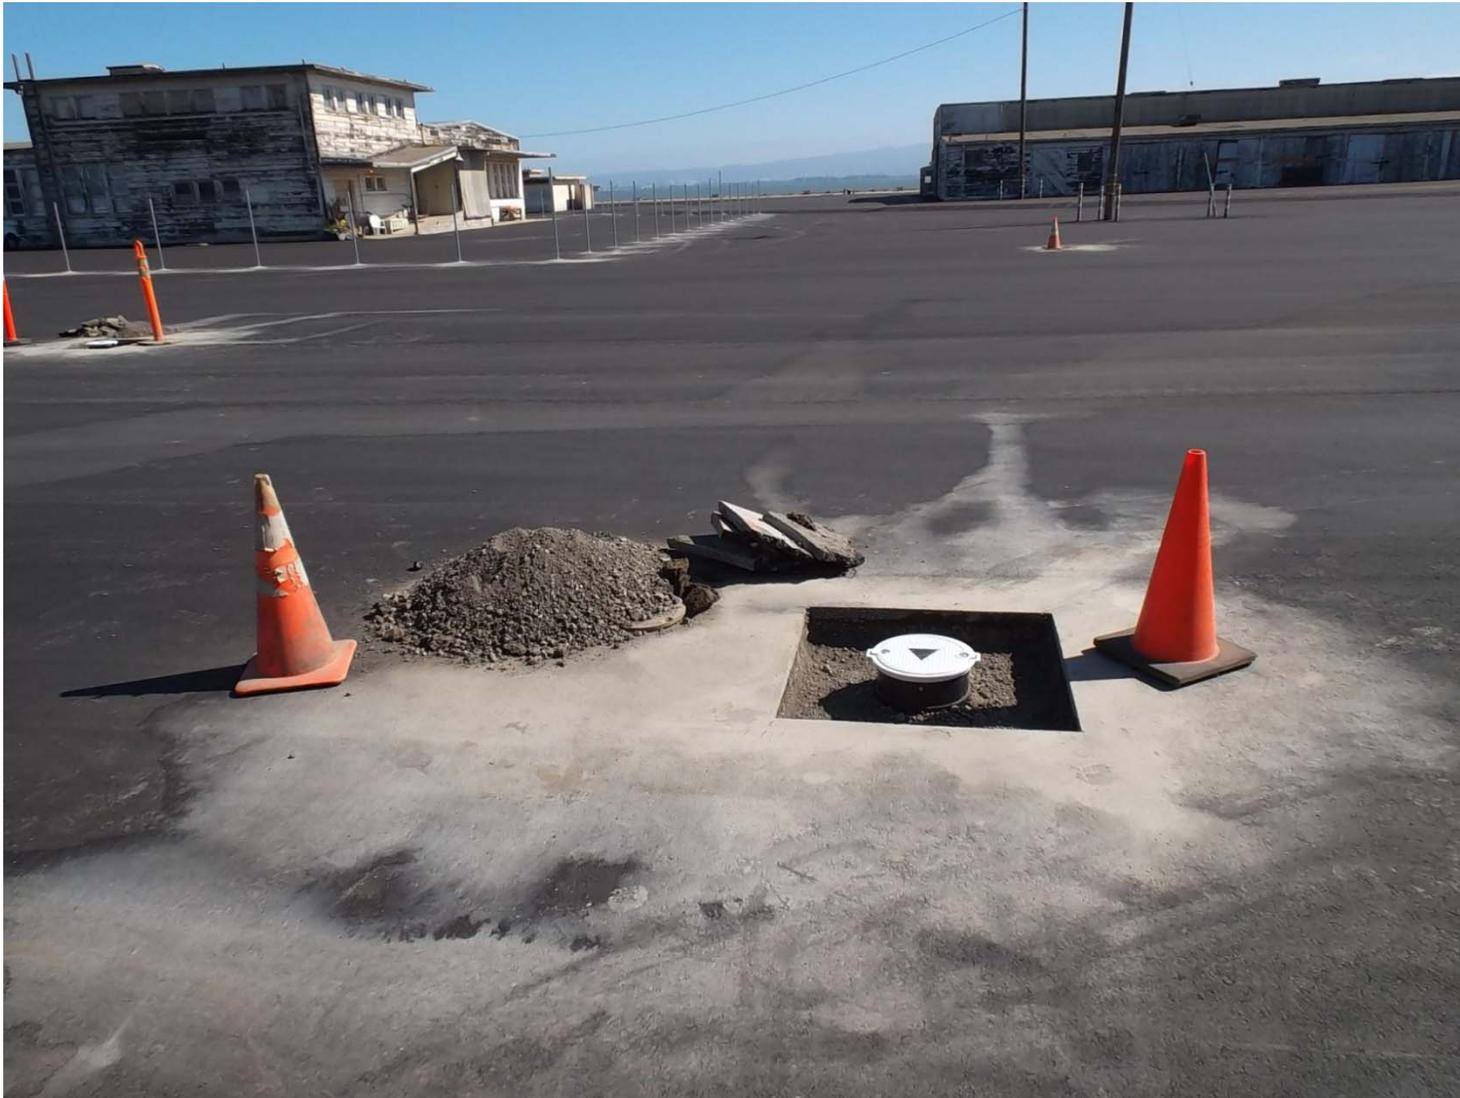
Fence Post Installation and Monitoring Well Extension

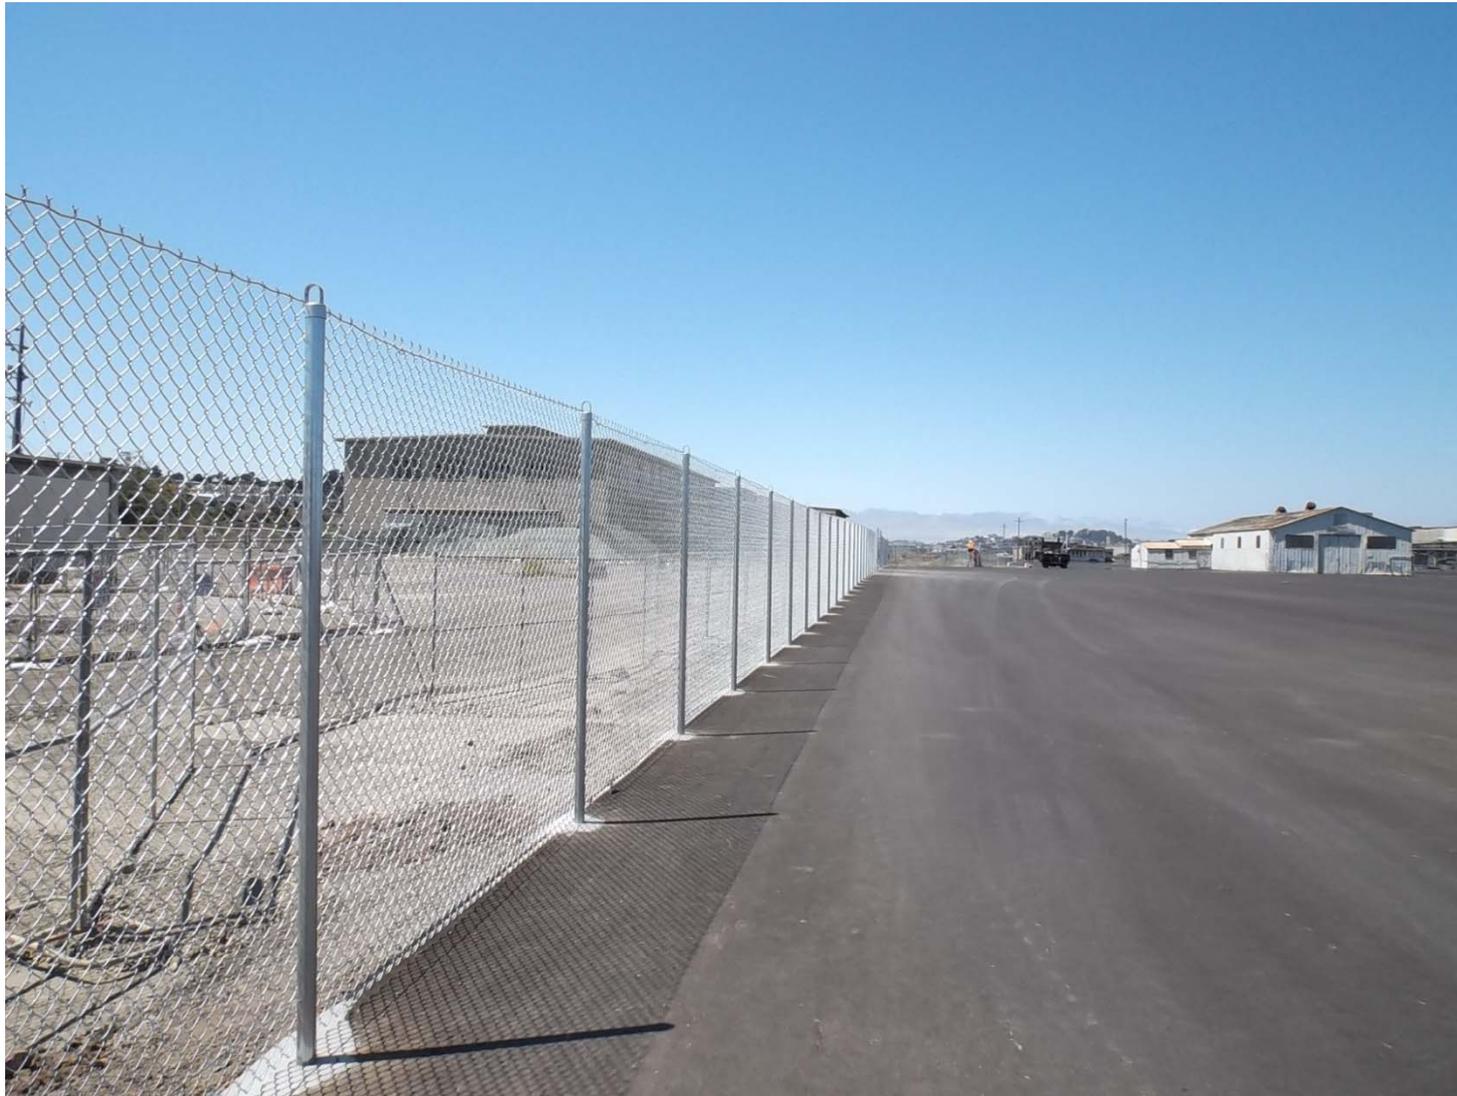
Completed Fence Along B/C Boundary
